Tohoku Pacific Earthquake and the Fukushima nuclear power plant

11. 03. 14 As of 14:00

Ministry of Economy, Trade and industry

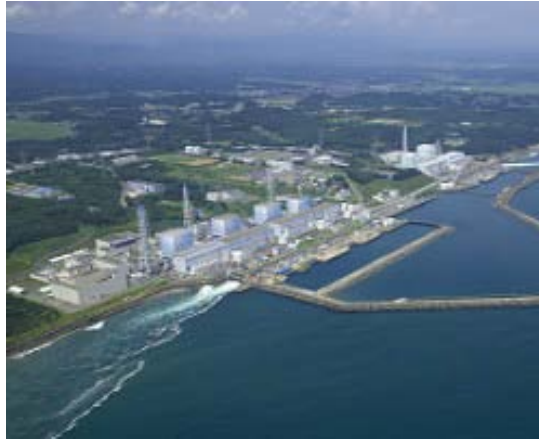
(Fukushima Dai-ichi nuclear power station)

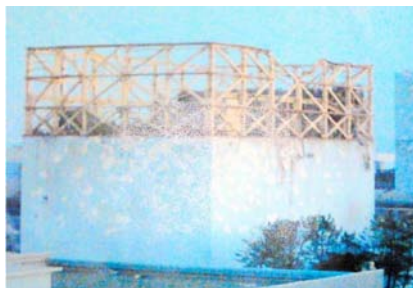
Unit 1 An explosion caused by hydrogen buildup blew the upper-part off a concrete building housing. What was occurring in the reactor was not a so-called “meltdown.” Its containment vessel was not damaged by the explosion.

- After the automatic shut-down of the reactor, water supply function run by seawater pump failed by Tsunami (it is believed that this was caused by Tsunami in which its scale was beyond our assumption), and the temperature of the reactor core went up.
- 12 March 15:36, water levels dropped inside the pressure vessel. Reacted metal and water generated Hydrogen, and the Hydrogen which leaked outside of the containment vessel caused the explosion.
- An explosion caused by hydrogen buildup blew the upper-part of a concrete building housing.

- Cesium and Iodine were detected, it is believed that a part of nuclear fuel was damaged and a small amount of radioactive material was leaked into core cooling water. However, this was not a so-called “meltdown” which means that whole reactor core melts down.
- It is confirmed that the containment vessel had not been damaged. There is no risk of a hydrogen explosion because there is no oxygen in the containment vessel. There is no risk of leaking large amount of radioactive material.
